Pilot Timber Sale – Unit 10

When: October 8, 2018

Purpose: Post-harvest soil disturbance monitoring, Round 2

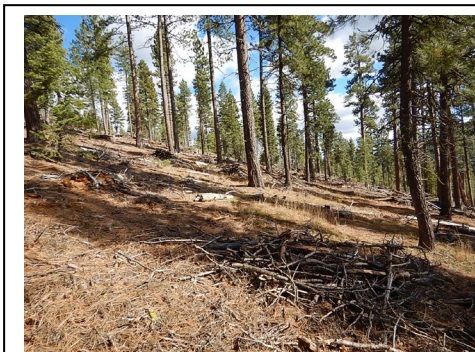
Fig. 3: General view, SW part of unit, hand piled.

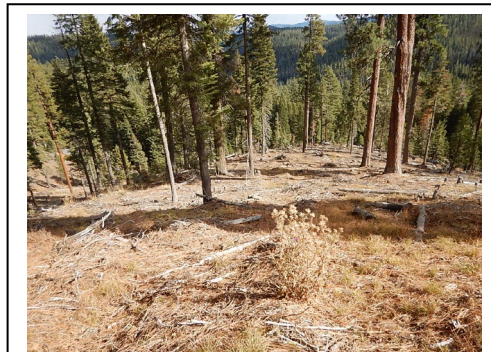
Fig. 4: General view of concave ridge, SW part of unit, hand piled.

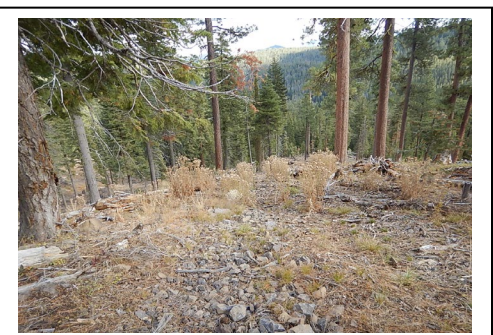
Several corridors, especially in the southwest and southern portion of the unit, display coarser or rockier soils. Increased bearing strength resulted in reduced overall impacts but, in places, removed some of the previous thin soil or vegetation, providing a setback in cover and a harsher growing environment.

Fig. 9: View NE from trail on rocky ridge near terminus of FS091. Thistle invasion.

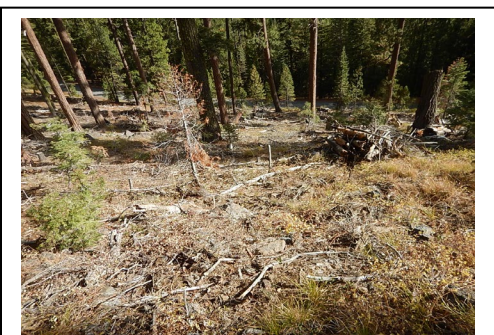
Fig. 10: Steep, rockier hand piled slopes below FS090 and lower boundary road FS3400.

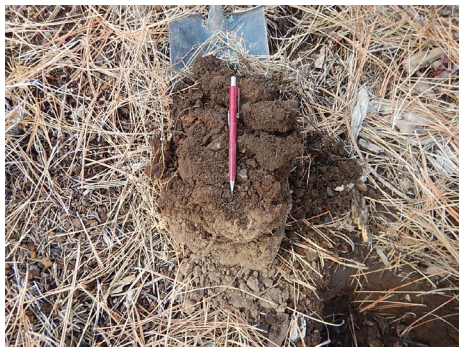
While compaction remained on the low end for the coarser sandy loam pumice, soils within cutting corridors showed increased platyness and massive structure. They were not as easily penetrated using the shovel test compared to undisturbed soils, though many remained in Class 1. Depth and level of compaction played a large role in determining if disturbance was considered detrimental.

Fig. 11: Platy compacted soils.

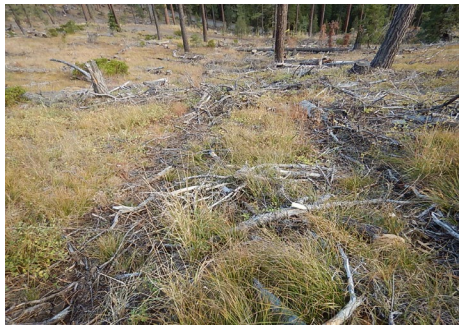
Fig. 13: General appearance of vegetation difference delineating equipment travel.

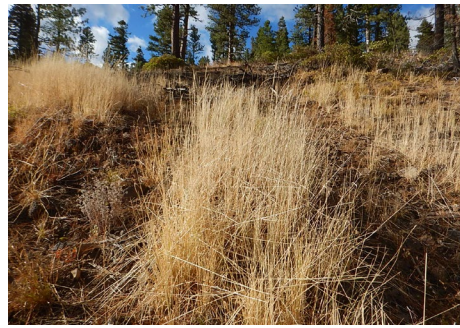
Fig. 14: Differences in vegetative growth define tracks where compaction increases.

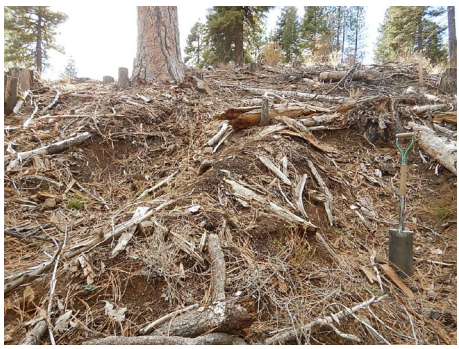
Primary soil disturbance comes from displacement and deeper ruts. Some of displacement remains difficult to discern where slash or extensive needle cast make it challenging to assess the forest floor. While compaction is not as widespread, it is present, especially where increased harvest volume and corridor length added to elevated forwarder travel.

Fig. 15: Deeply rutted and displaced soils.

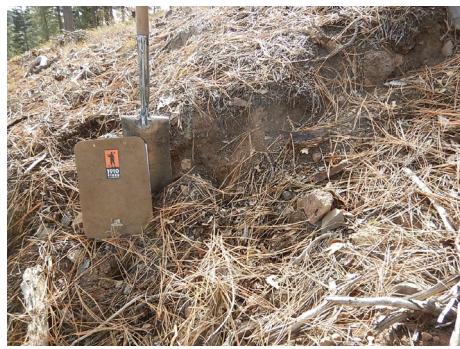
Fig. 16: Side view of rutted tracks in corridor.

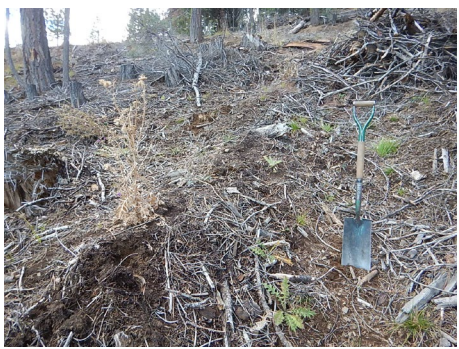
Fig. 17: Displacement, thistles, and more.

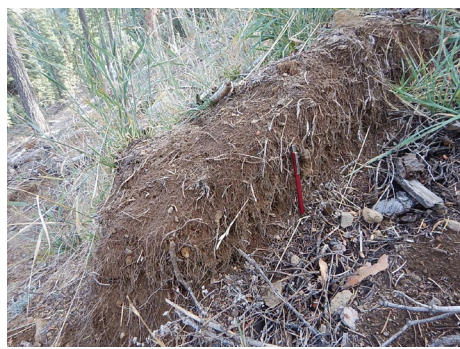
Fig. 18: Extreme berm from side tracking.

Corridor/trail spacing was ~25 to 40 feet and driven by boom reach limitations of the equipment. Corridors primarily paralleled each other perpendicular to the contour but also converged and overlapped based on topography, steepness, and/or location of roadside decks. Side tracking was observed in some parts above the mid-slope road FS090. Similarly, several old non-system roads from a previous treatment were discovered during pre-harvest reconnaissance, were in part re-utilized, and remain on the landscape.

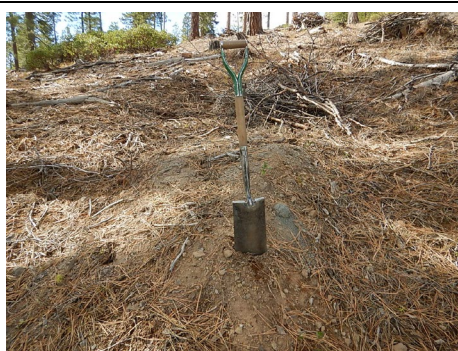
Fig. 19: Center mound and tracks.

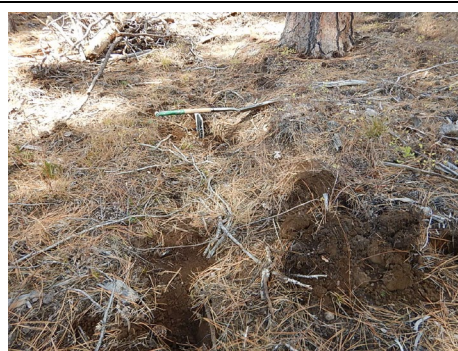
Fig. 20: Deep depressions along tracks.

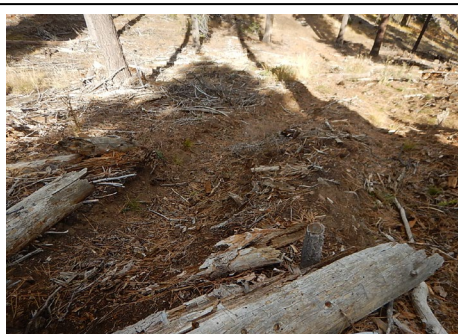
Fig. 21: View down onto connector trail between FS090 and 091.

Compaction, though not as widespread as displacement, was found frequently but was not deemed detrimental in many cases, especially when limited to the uppermost inches of surface soil. One main forwarder trail connected the 091 and 090 roads over a rocky ridge (Fig. 21). Its evolution was tracked during several visits while operations were ongoing. Initial extensive impacts were attempted to be remedied at this location by smoothing over the deep ruts and berms that established on this east-facing slope. While some mitigation occurred, the area was impacted and provides added opportunities to observe and track potential recovery.

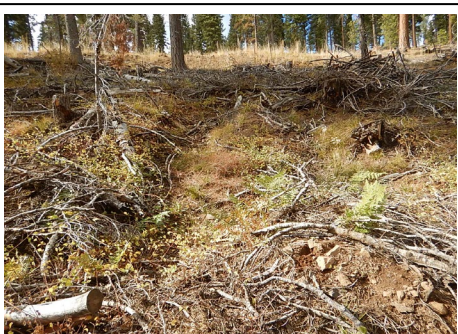
Fig. 22: Visible track depressions with veg regeneration.

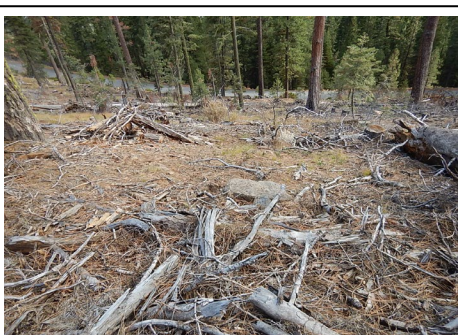
Fig. 24: More resistance, fewer impacts towards trail bottom; rockier, less traffic.

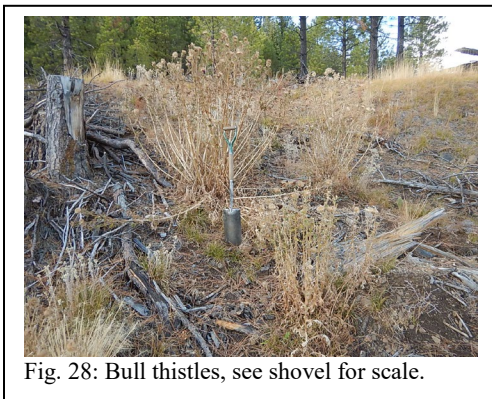
Unfortunately, bull thistles and a lesser amount of Canada thistles are spreading across the treatment area from disturbed localities, such as trails and decks, to undisturbed areas.

Fig. 28: Bull thistles, see shovel for scale.

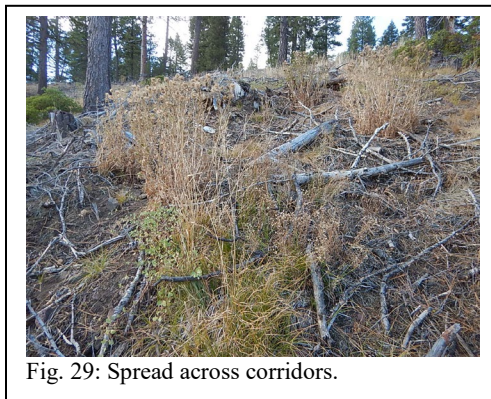
Fig. 29: Spread across corridors.

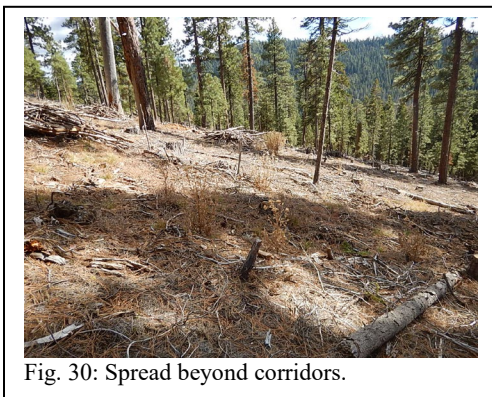
Fig. 30: Spread beyond corridors.

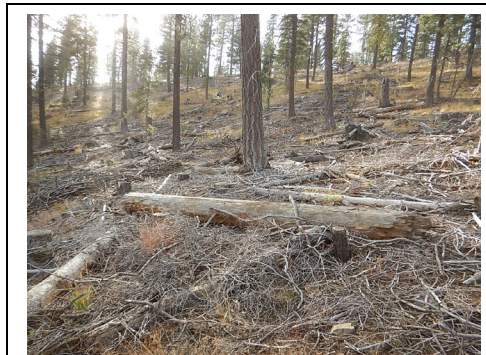
Fig. 34: Untreated slash remains.

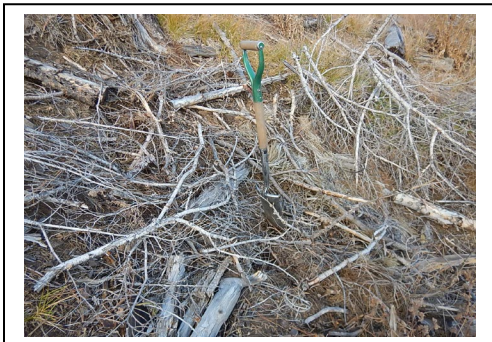
Hand piling across the western half has greatly reduced slash levels. At the time of the visit, the eastern half was not piled but slash was much less pronounced since needles have dropped and branches and smaller debris have been compressed. Some areas with thicker accumulations (>1 foot) remain.

Fig. 35: Deeper slash remains in some places.
